Watershed project summaries and the §319 success story.

Muddy Creek Dream Mountain Project Summary

Indian Creek project summary

Muddy Creek Watershed Restoration Projects and Partnership Improve Water Quality of Cheat River

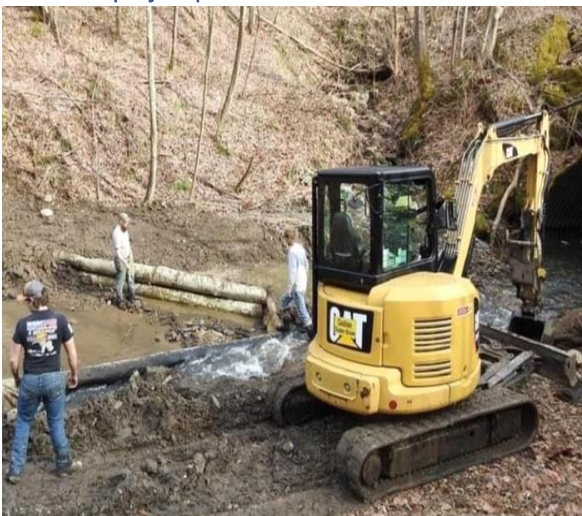
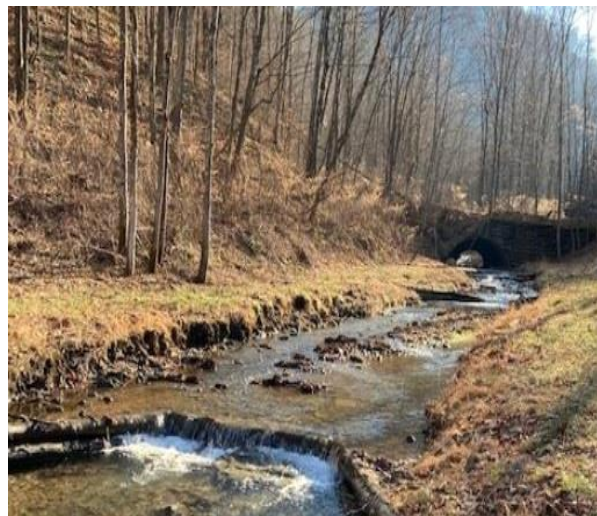
Stream structures being placed during the early phase of the Morris Creek restoration. Shortly after installation a heavy rain event occurred but the structures remained stable.

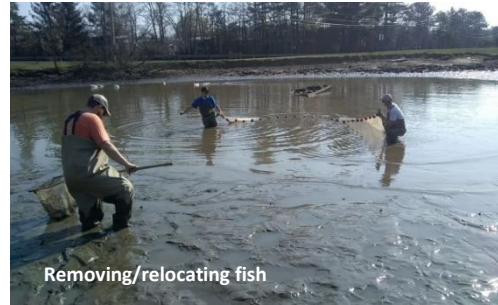
Removing/relocating fish

Piney Creek wetland/stream restoration progression...

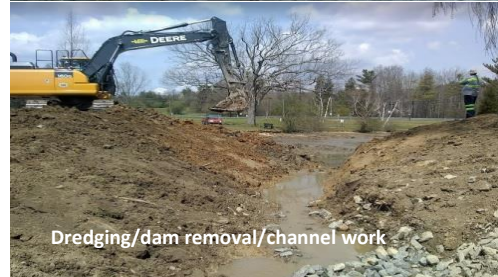
Dredging/dam removal/channel work

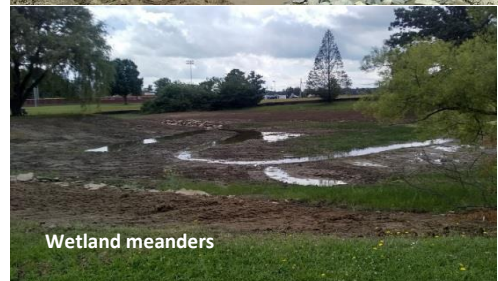
Wetland meanders

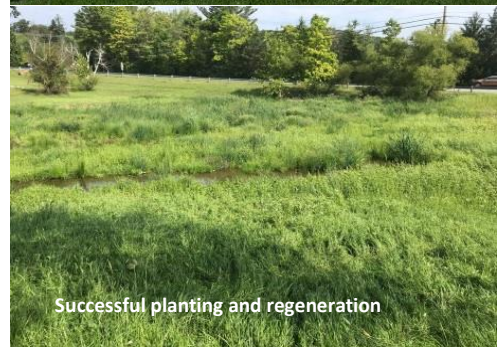
Successful planting and regeneration

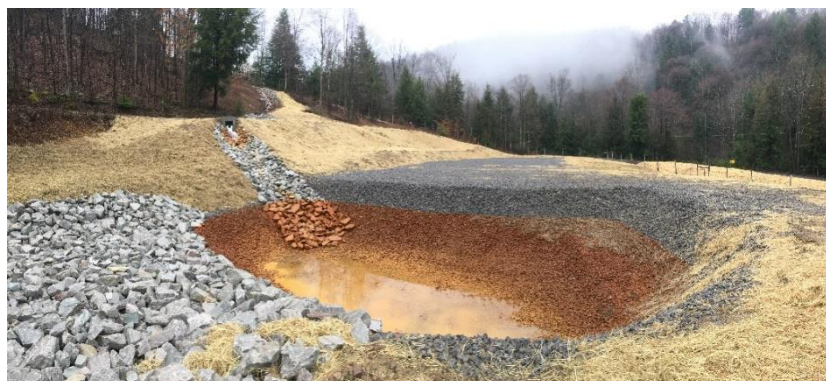
4,750 ton Auto Flushing Vertical Flow Pond filled with 90%+ CaCO₃ content limestone.

In September 2019 FOC procured BioMost, Inc. to design passive treatment system improvements at Dream Mountain. The design consisted of converting the existing steel slag bed into a 4,750 ton auto flushing vertical flow pond filled with high quality (90% CaCO₃) limestone, converting the mixing basin to settling pond, and improving the existing connections between treatment components. FOC then procured a construction contractor (Blue Gold Development, LLC) in December of 2020. Project construction went smoothly, and the project reached substantial completion on April 27th, 2021.

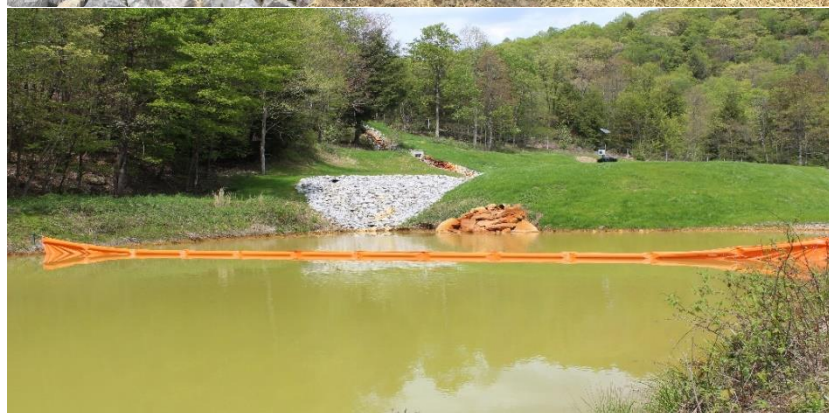
Newly dredged settling pond with greater storage capacity.

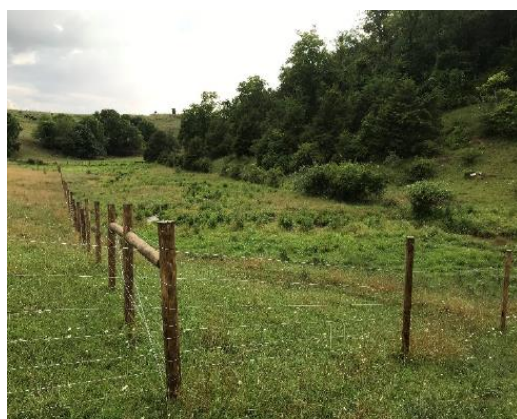
Stream exclusion fencing with a riparian buffer.

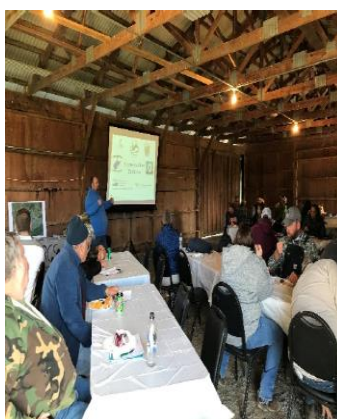
Field day presentation/lunch and fencing demonstration

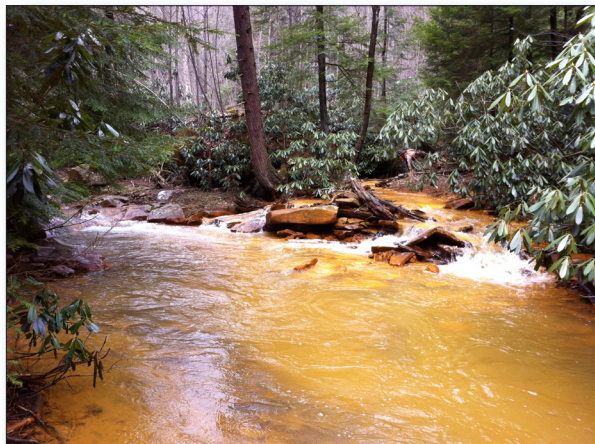
Figure 2. Iron-laden, acidic water from Fickey Run, center, discharged into Martin Creek, a tributary of Muddy Creek, before the restoration project.

AMD pollution in Muddy Creek comes from coal mines, where pyrite, a mineral in the coal, oxidizes to form dissolved iron and sulfuric acid, which dissolves additional metals from rock and soil (Figure 2). In 1994, water in a mine void in the T&T Mine Complex “blew out” through a hillside. The AMD polluted not only Muddy Creek but the entire Cheat River, its receiving stream. The blow-out called attention to the need to neutralize hundreds of other long-term AMD sources in the Muddy Creek and Cheat River watersheds.
